## WE NEED A BETTER COAT?

By Bill Lape, SCS Engineers

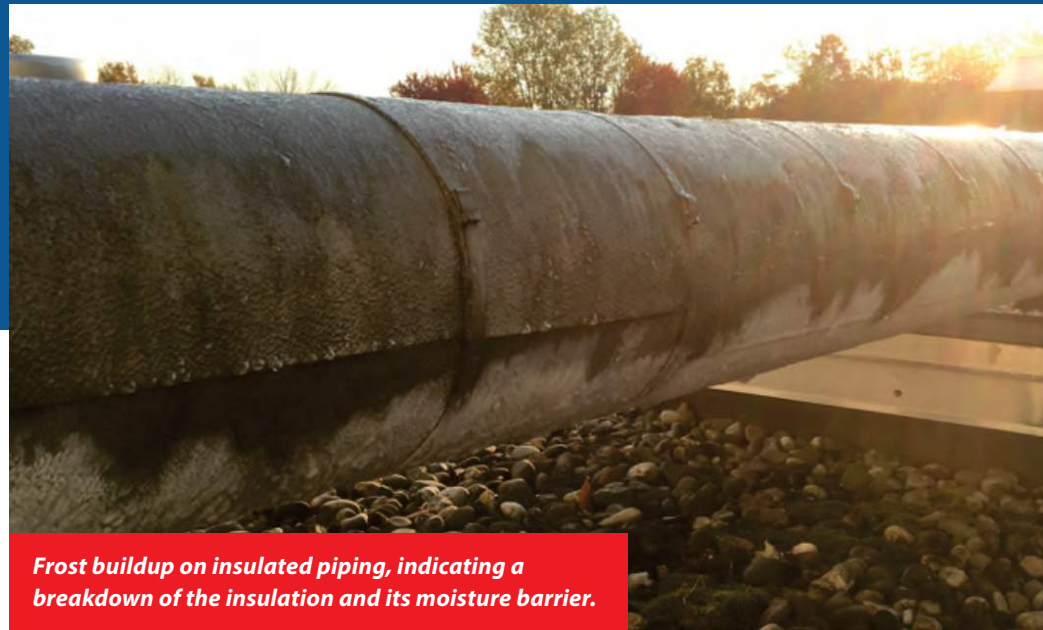
*Frost buildup on insulated piping, indicating a breakdown of the insulation and its moisture barrier.*

If damage, degradation, or moisture incursion is identified, IIAR6 requires that the insulation be removed, as needed, at the areas of concern to evaluate the piping underneath. Had to add a pipe

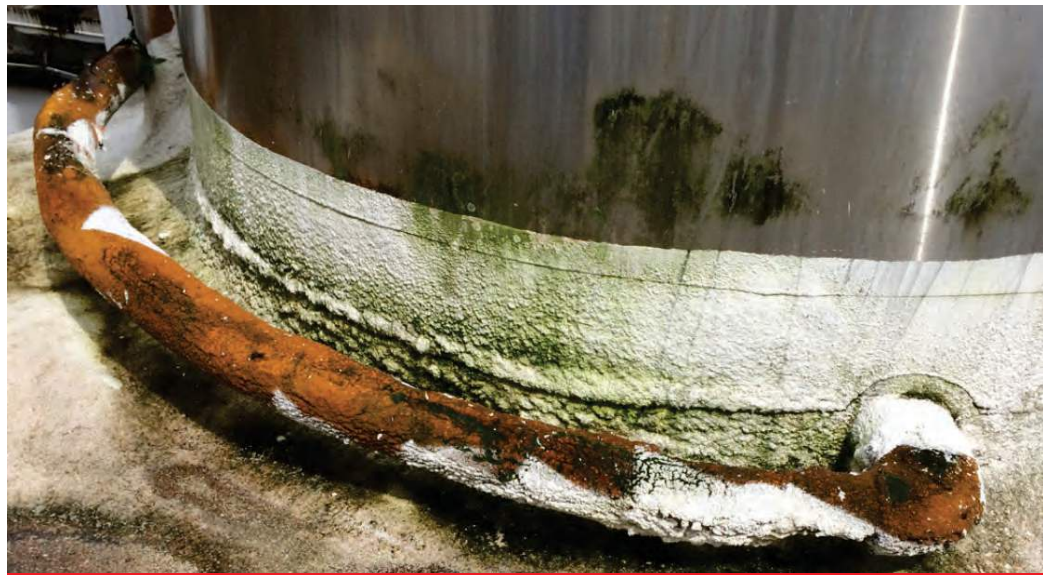
*Armaflex insulation, mastic coating, and multiple layers of mold.*

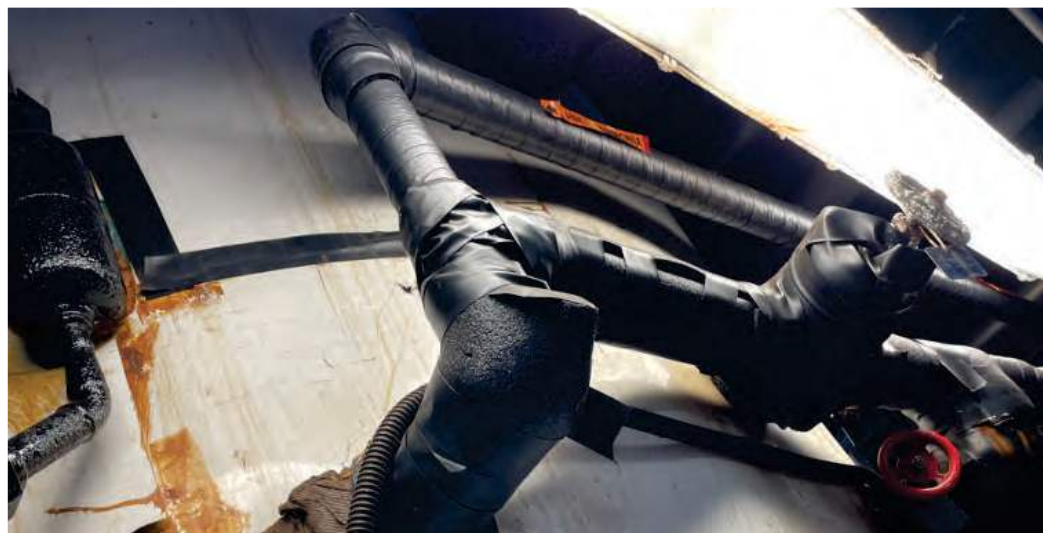
*More heat shrink or electrician's tape? Over Armaflex, no less.*

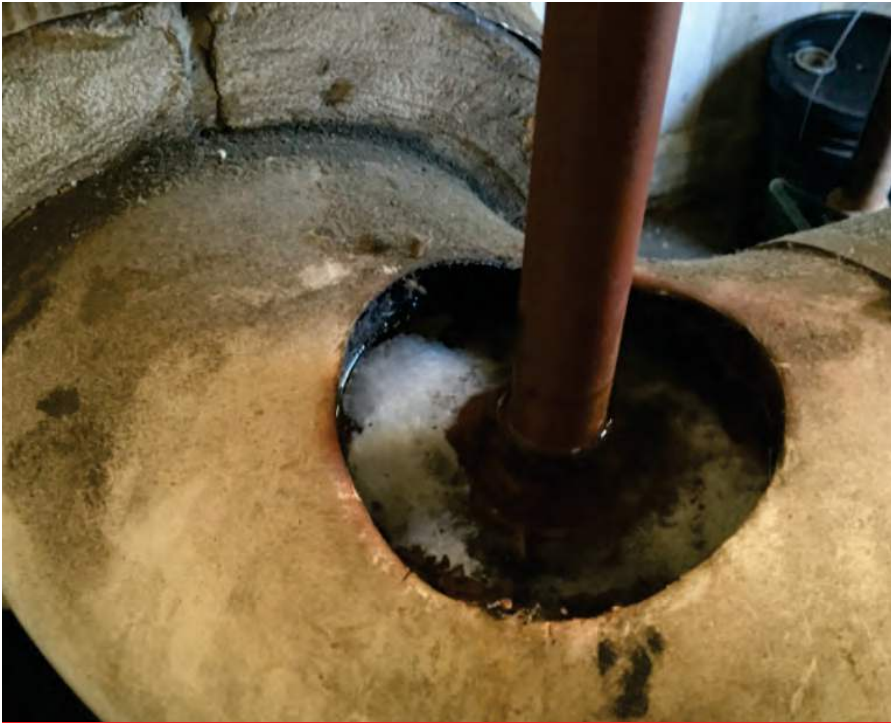
*Had to add a pipe but ran out of money to repair the insulation.*

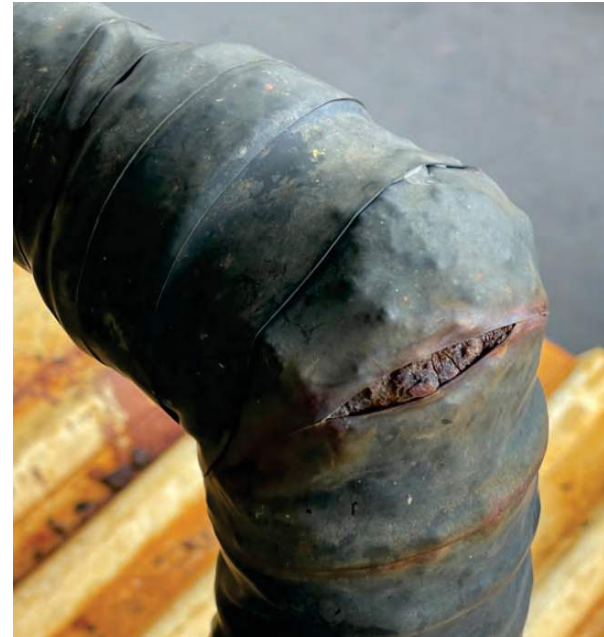
*Heat Shrink insulation?*

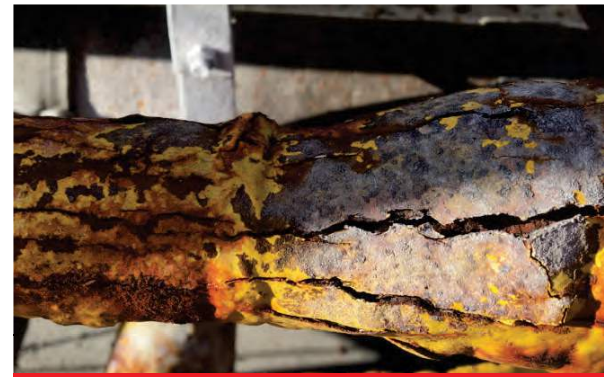
*Extreme corrosion on a condenser drain line.*

11.1.1.2 Where pitting, surface damage, general corrosion, or a combination thereof, has not materially reduced the remaining pipe wall thickness, the piping metal surface shall be cleaned and recoated to arrest further deterioration. **We must clean the corrosion from the pipe and repaint it.**

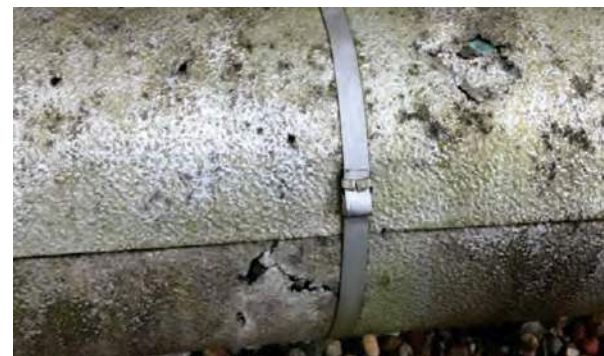
*Protective jacket deterioration.*

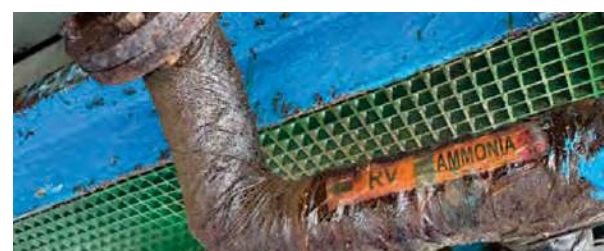
*Not really sure what this coating is.*

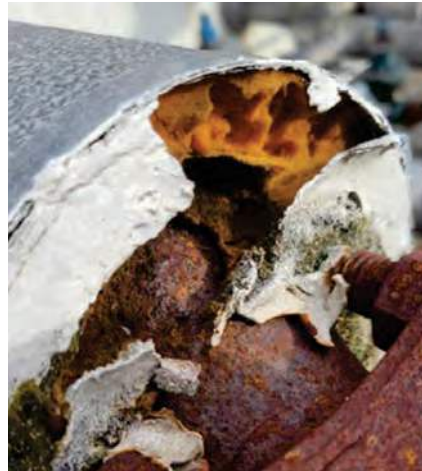
*Deteriorated mastic coating at the end of insulation*

Let's look further at what IIAR6 has to say about insulated piping. Section 11.1.2 states, for insulated piping, where insulation is removed, partly or completely, for visual inspection or remaining wall thickness measurement(s), a protective coating shall be applied to the exposed metal surface and insulation shall be replaced in accordance with the manufacturer's installation instructions after arresting any identified exposed piping metal surface corrosion. **The protective coating called for here can be paint, or a reactive gel that acts as a rust converter and corrosion inhibitor. After this is applied, the insulation must be replaced.**

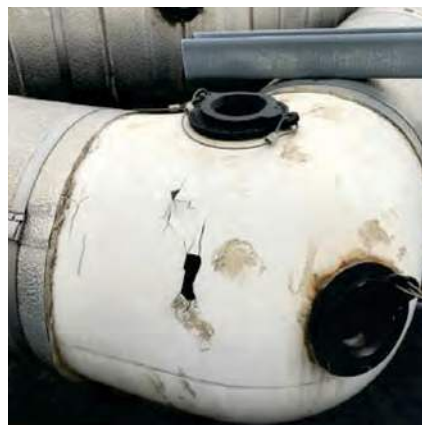
*Deteriorated PVC elbow, but, by gosh, we've inspected it.*

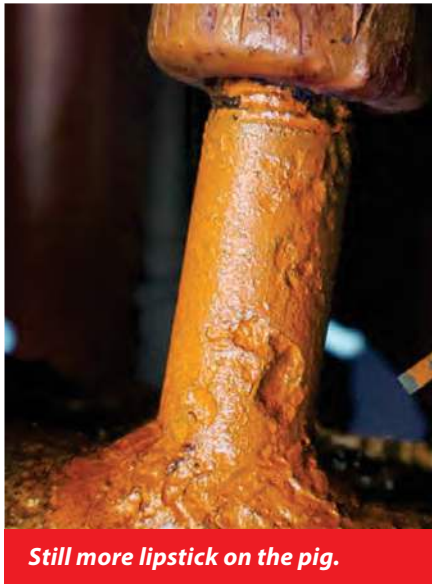
**Still more lipstick on the pig.**

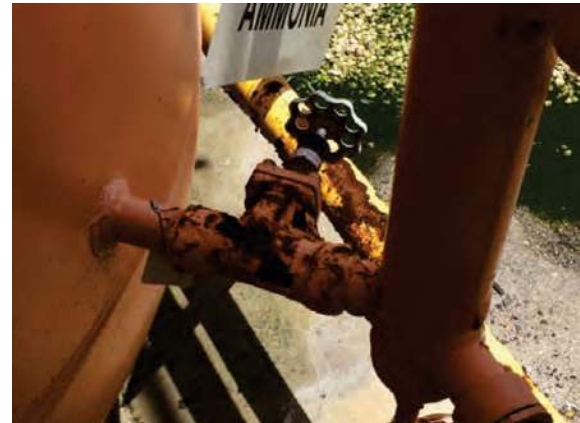
**Pitted valve that was less than five years old when the photo was taken.**

11.1.1.1 Where pitting, surface damage, general corrosion, or a combination thereof, has materially reduced the remaining pipe wall thickness, the piping remaining wall thickness shall be measured using appropriate techniques. **We must measure the remaining wall thickness using a pit gauge or other suitable non-destructive testing technique.**

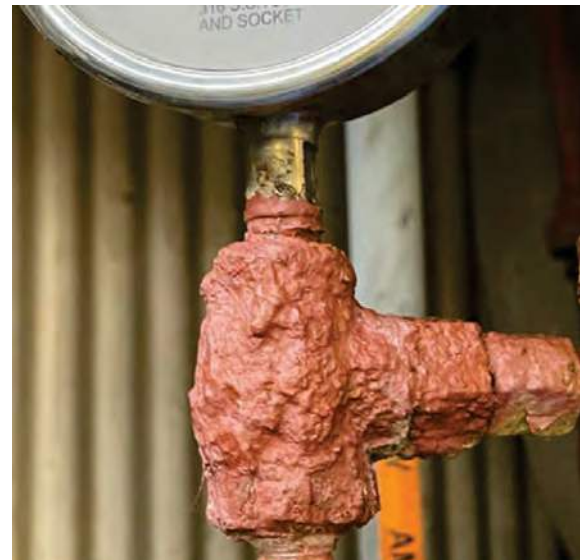
**Not entirely sure what this is on the valve.**

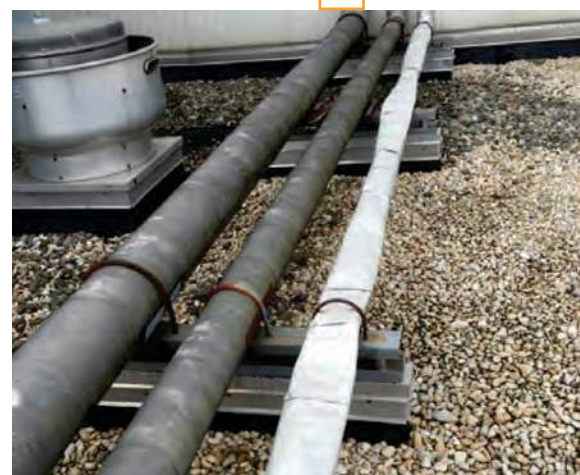
**Insulation breakdown, maybe after an army stepped on the pipe**
