EPIC FAILS

ATTENTION TO DETAIL (OR MAYBE LACK THEREOF)

By Bill Lape

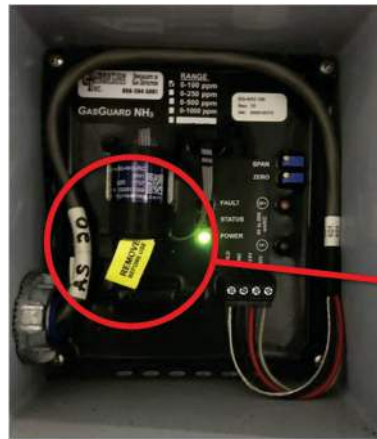
The ammonia detector above had been in operation for approximately eighteen months when this picture was taken, meaning it would have had to be calibrated four times, which is hard to do when the sticker that protects the electrochemical cell from premature aging due to exposure to air and contaminants had not yet been removed.

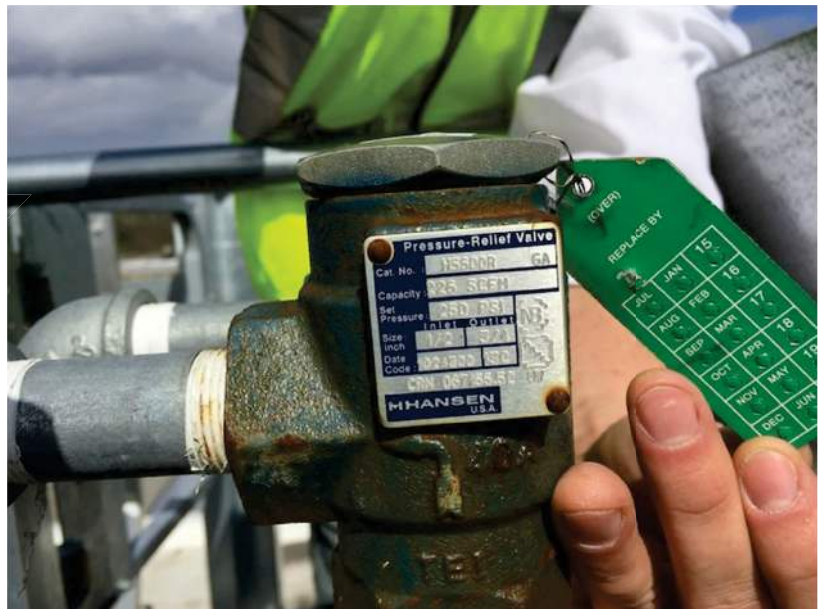
The SRV pictured below had been installed sometime within the previous five years based on the manufacturer's date code, but exactly when is not identifiable given that the install/replace tag had not been punched.

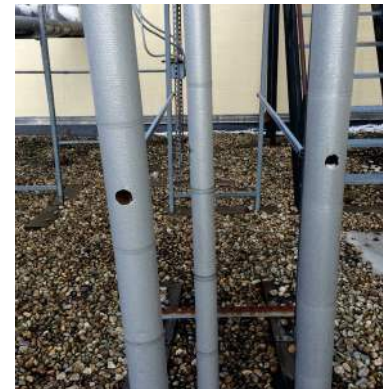
The facility in the picture right was attempting to do the right thing by conducting non destructive testing of pipe that had been identified areas that have experienced possible corrosion. However, by not properly plugging the insulation holes created to use the ultrasonic thickness probe, they have, in fact, created a path by which corrosion can occur.

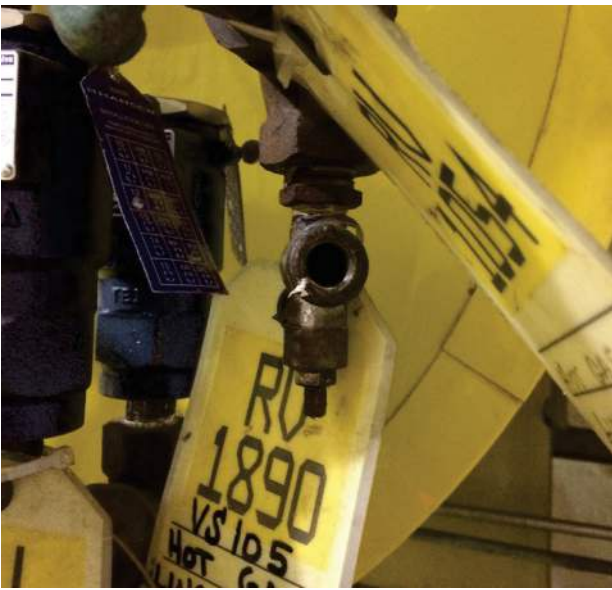
As operators get pressed for time, they often overlook final steps in operating procedures, such as reinstalling plugs on drain valves.

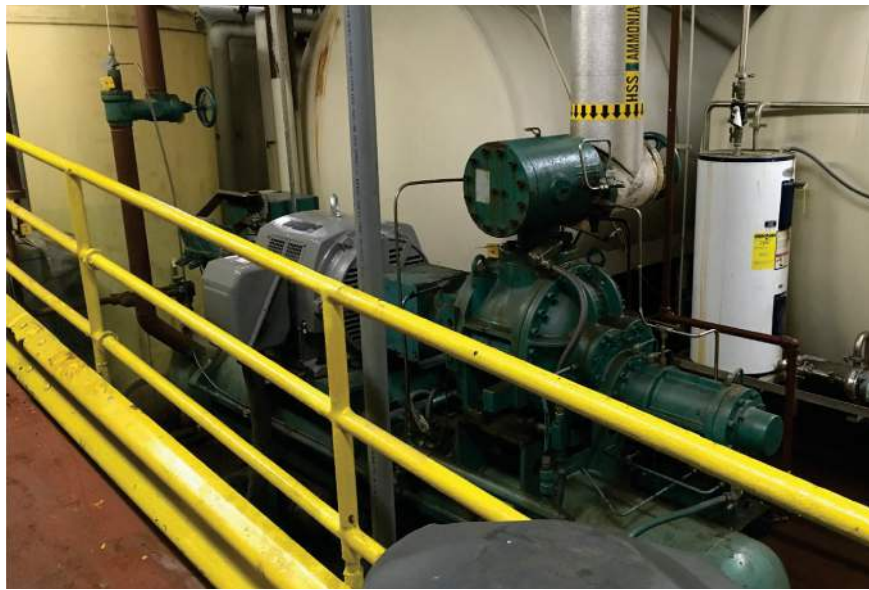
The facility in the picture above needed a different suction temperature to run air handling units for an area of their production facility. Rather than installing the compressor in the machinery room in the basement and running the suction header out to the air handling units, they installed the compressor in the middle of the production area.

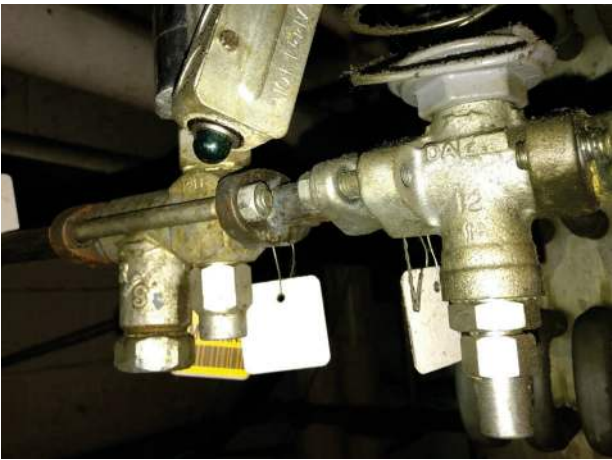
Or, they may not take the time to find the proper bolt for full thread engagement.
