EPIC FAILS

ATTENTION TO DETAIL (OR MAYBE LACK THEREOF)

By Bill Lape

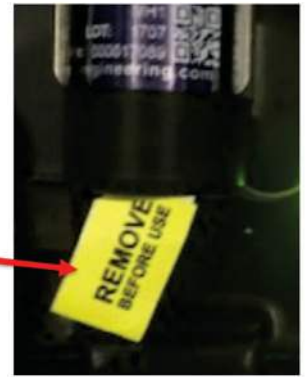
The ammonia detector above had been in operation for approximately eighteen months when this picture was taken, meaning it would have had to be calibrated four times, which is hard to do when the sticker that protects the electrochemical cell from premature aging due to exposure to air and contaminants had not yet been removed.
