ICE BUILDUP REVISITED

By Bill Lape, SCS Engineers

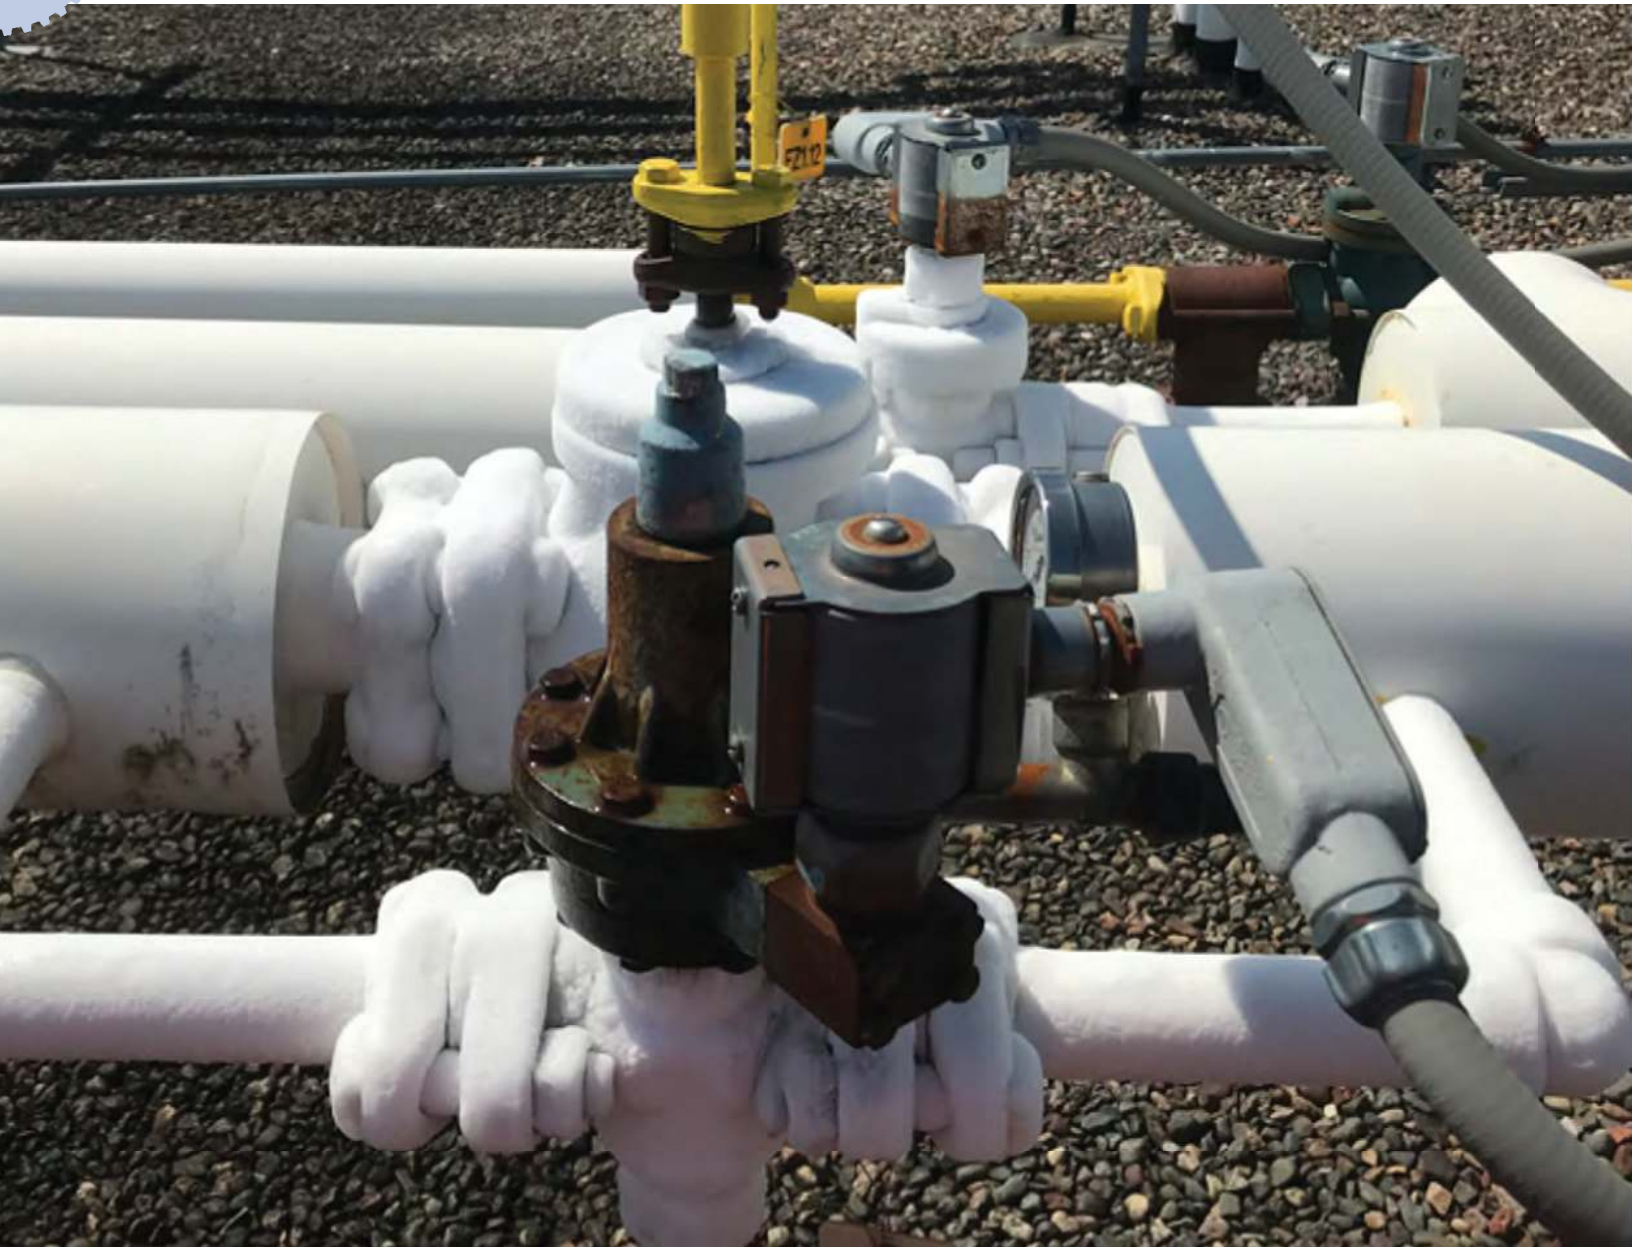
But what about a more significant amount of ice buildup on a valve train? Say, perhaps what is evident in the picture on the top right?

Now we have an issue. Because the ice buildup has progressed to the point where we are unable to physically operate the valve's manual stem, we must first defrost the valve.

Is this out of compliance? Well, it depends on the situation. IIAR6 states in Section 5.6.8.1 that, "Ice buildup shall not interfere with the operation of emergency shut-off valves."

While some may argue that the manual stem is not an emergency shutoff valve, if it is ever intended to be operated during an emergency shutdown of its associated equipment, then it becomes part of the emergency shutdown procedure for that equipment and, as such, it is now out of compliance with Section 5.6.8.1. So, be mindful of your emergency shutdown procedures. Review them and evaluate any maintenance requirements that may arise based on the valves that are identified in the emergency shutdown procedure.

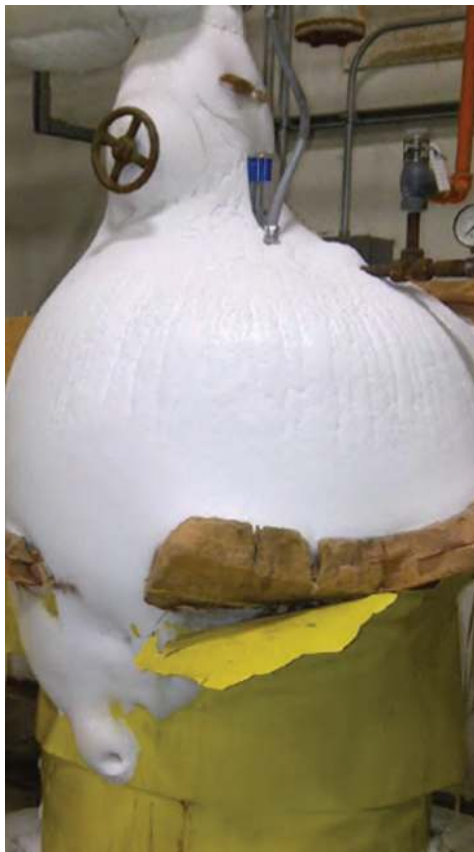
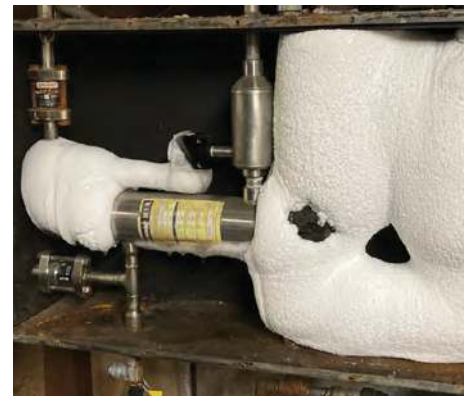
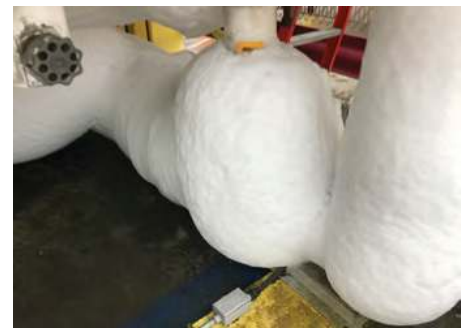
Here are some more examples of possible "excessive" ice buildup:

Insulation is a component of the refrigeration system. If it is displaced by ice, then it is not compliant with IIAR6, Section 5.6.8.2.

IIAR6 goes on to state in Section 5.6.8.2 that, "Ice accumulation shall not be permitted to deflect or bend pipes, displace components, or negatively impact the system's structural integrity."
